**MANHOLE INSPECTION**  
**TECHNICAL MEMORANDUM**

**Subject:** Sanitary Sewer and Water System Evaluation Study  
Manhole Inspection Memorandum of Field Work

**1997 FLOW MONITORING PROGRAM  
TECHNICAL MEMORANDUM**

SUBJECT: COUNTY OF SAN MATEO MASTER PLAN  
1997 FLOW MONITORING PROGRAM

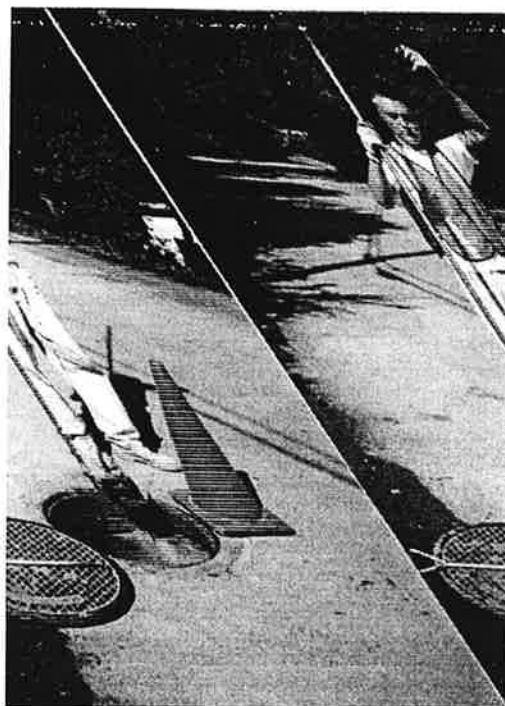
In order to collect additional data on each manhole location a “Camera on a Stick” (Figure 1) was lowered into the manhole and a photograph of each pipe entering and leaving the manhole was taken. Where infiltration/inflow or other manholes conditions warranted a photograph was also taken from the “Camera on a Stick”.

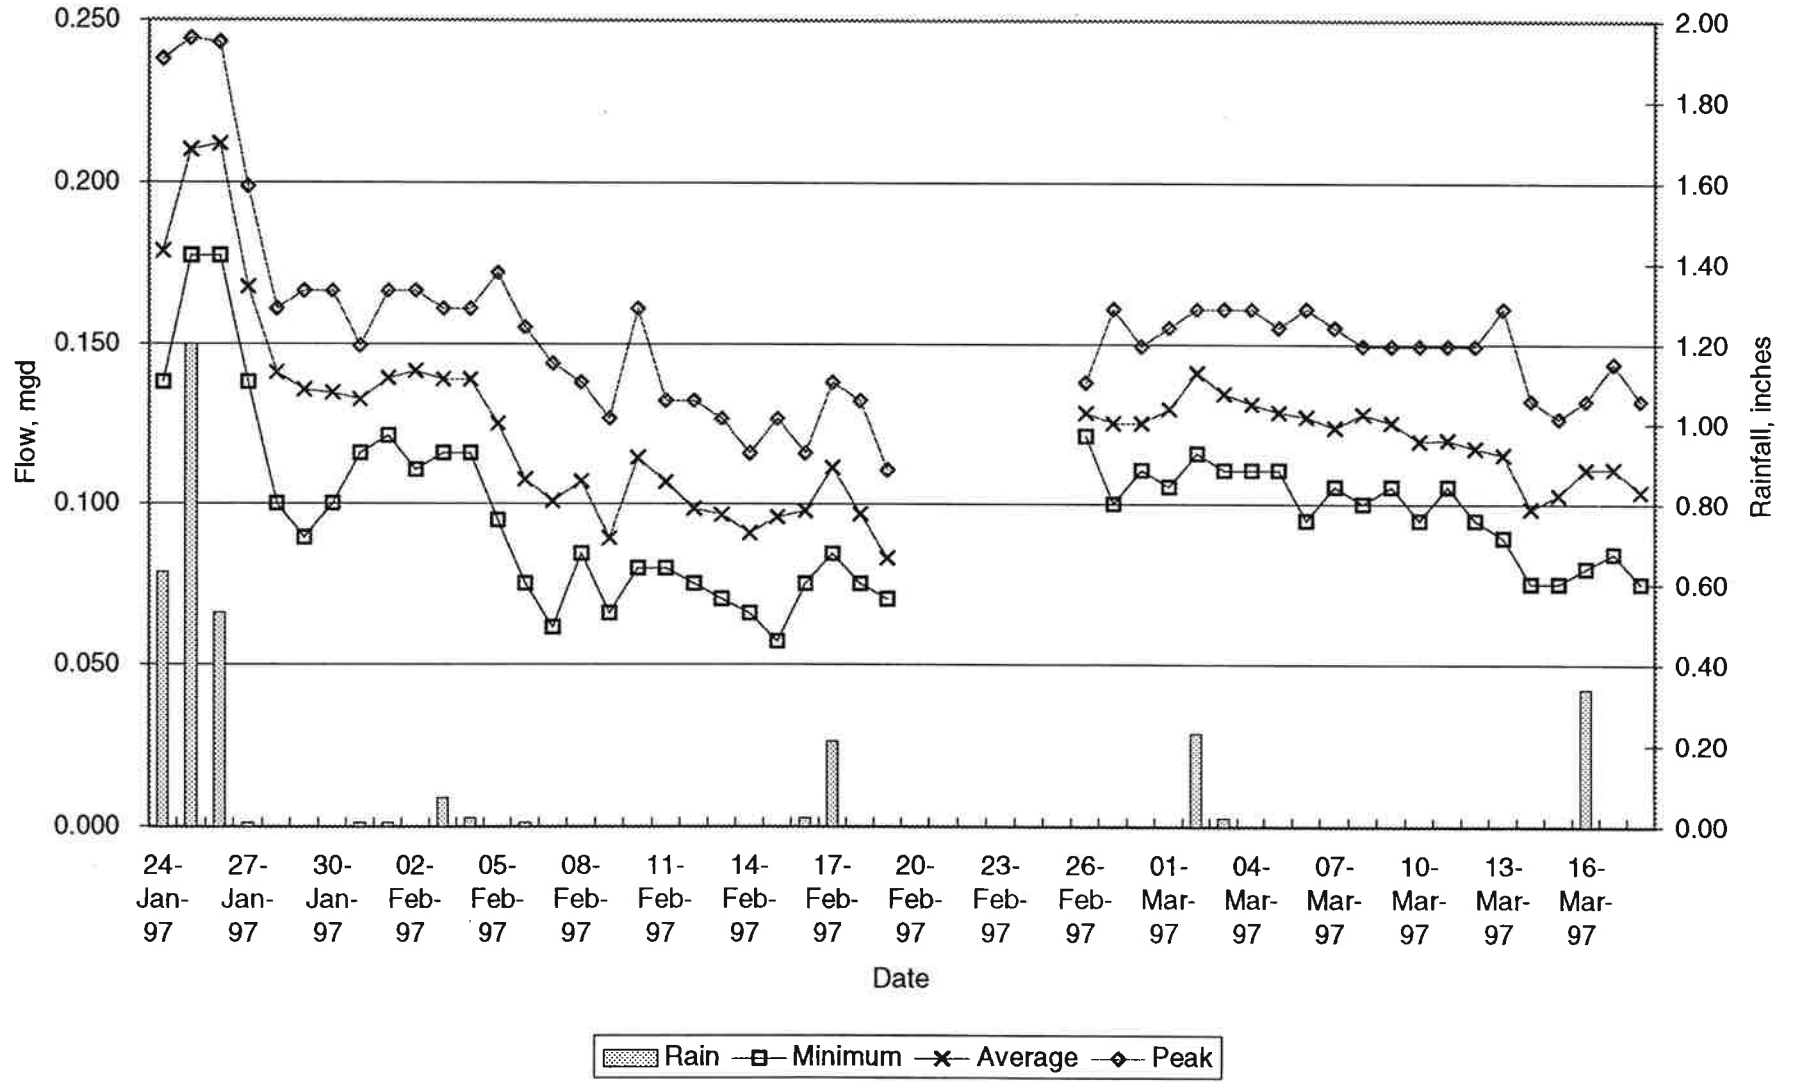
Country of San Mateo  
 Daily Flow Rates -- Site 12 -- 2872 Canyon Rd.  
 8" Diameter

The flow monitors at sites 12 and 44 either failed or became clogged with debris, for noted periods of time. For site 44, we do not recommend using the flow data from February 23, 1997, to March 16, 1997, as flow levels were too low to measure accurately. Also, flow monitoring at site 12 failed from February 20, 1997, to February 25, 1997. No additional monitoring problems were noted. Table 4 presents the dry weather and wet weather flow monitoring results of this analysis.
