Preliminary Arborist Report

**Skylonda Fire Station
Woodside, CA**

November 25, 2015

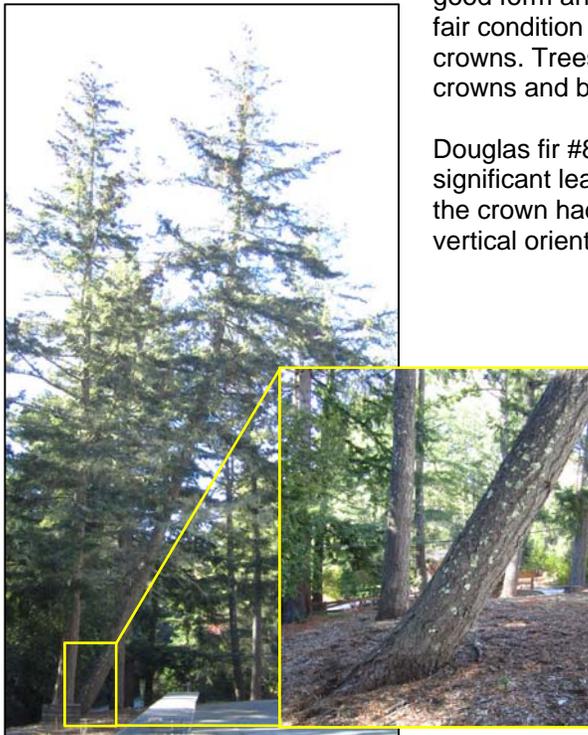
Douglas fir #80 was in fair condition with a significant lean north (Photo 1). The upper portion of the crown had corrected and was growing in a vertical orientation.

Photo 1: Tree #80 was mature in development with a significant lean from a previous partial failure at the base (inset). The tree had been growing this way for a long time, as evidenced by the top half of the tree that was growing in an upright direction.

Douglas fir #80 has a significant but corrected lean north. If the tree were to fail at the base, I estimate the existing apparatus building is within the fall zone. The vertical orientation of the upper portion of the tree indicates the tree developed with the lean and the lean has been present for some time. I do not believe tree failure is imminent; however, a tree with a significant lean has a higher likelihood of failure than one that is growing upright. The decision as to how much risk is acceptable at the site can only be made by the property owners. For the purpose of this report, I recommend preservation of tree #80 unless owners decide otherwise.

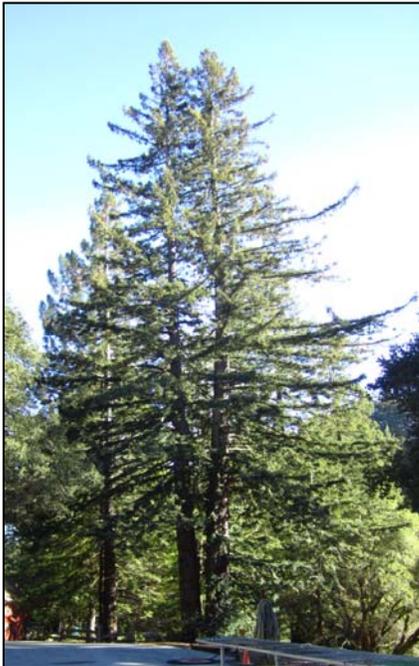
Photo 2 (left): Tree #82 had two trunks (55" and 40") arising from near the base of the tree. The tree was in fair condition with a slightly thin crown.

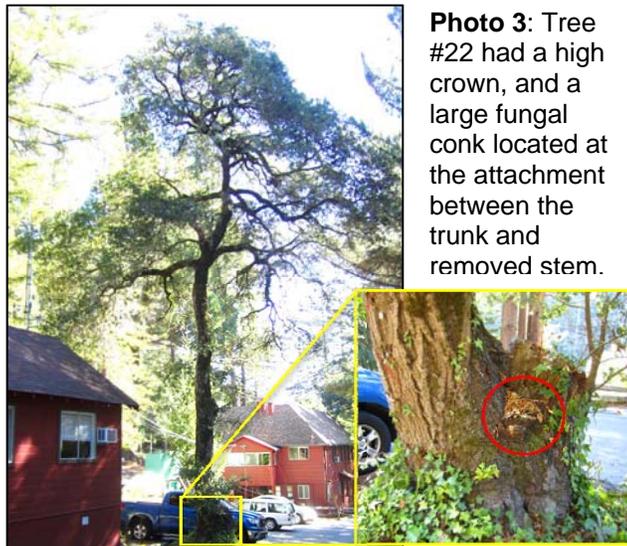
Fifteen (15) coast live oaks (16%) were evaluated at the site. Trees were young to mature, with trunk diameters from 6 to 31 inches. The average size for single-trunk trees was 14 inches. Most trees (12 trees) were in fair condition with fair form and structure; three trees were in good condition with dense crowns and good form. The two largest oaks – #22 (27") and 42 (31") – were located adjacent to the drive aisle and were surrounded by asphalt. Both trees were in fair condition with fair structure and moderate vigor. On tree #22, a *Ganoderma* conk (fruiting body of decay fungus) was located on the stump of a removed stem, an indication of internal decay (Photo 3). Tree #42 had multiple trunk wounds and good form.

Photo 3: Tree #22 had a high crown, and a large fungal conk located at the attachment between the trunk and removed stem.

Tree #	Species	Diameter	Reason for removal
19	Coast redwood	21	Grading; new retaining wall N. of tree
21	Douglas fir	6	Within new parking lot
22	Coast live oak	27	Within new filtration area
23	Douglas fir	15	Within new driveway to Skyline Blvd.
24	Pacific madrone	11	Within new driveway to Skyline Blvd.
25	Tanoak	14	Within new driveway to Skyline Blvd.
26	Pacific madrone	5	Within new driveway to Skyline Blvd.
27	Pacific madrone	10	Within new driveway to Skyline Blvd.
42	Coast live oak	31	Within new driveway to apparatus bay
89	Plum	10	In decline
